G. Volpato, LLC DBA
National Property Inspections

Town Of Southbury, 100 North Benson Road, Middllebury, CT, 06762

COMMERCIAL PROPERTY INSPECTION PROPOSAL & AGREEMENT

1. **Description of property:** This is a Bath and Tennis Club.

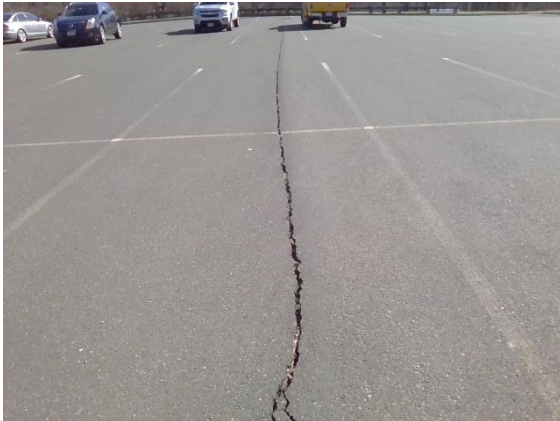
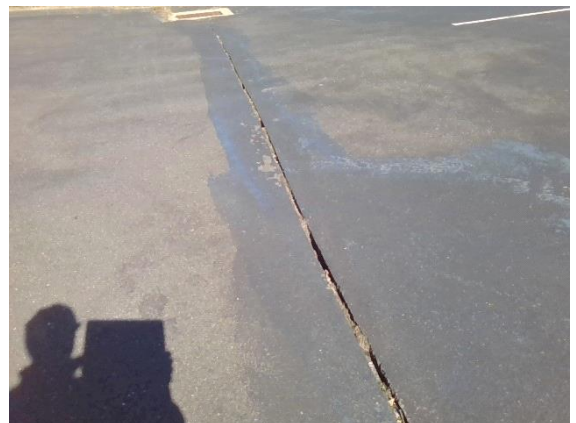
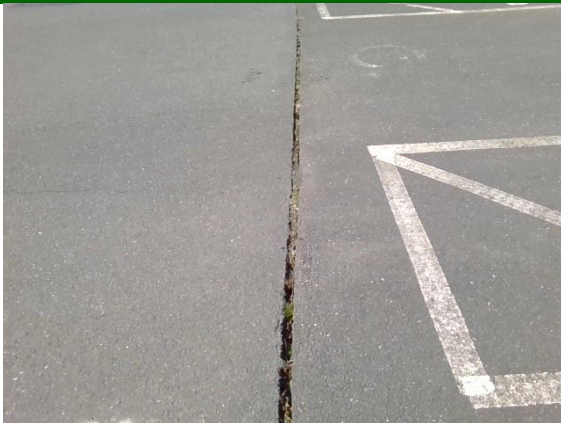
Parking lot and driveways have some age typical cracking and has several open seams which should be sealed.

Parking Lot / Driveways: cracked seam

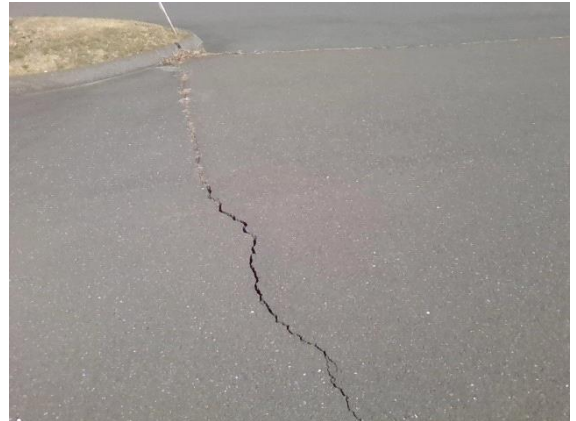
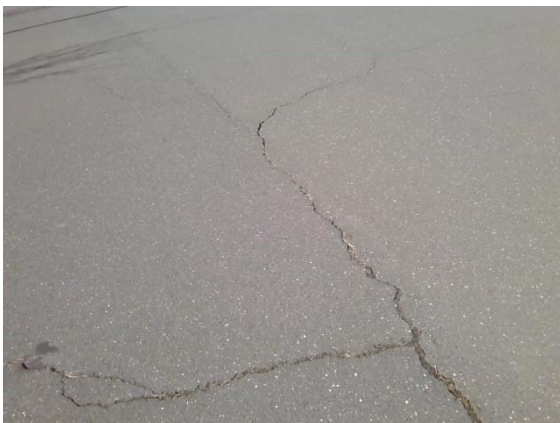
Parking Lot / Driveways: typical cracking

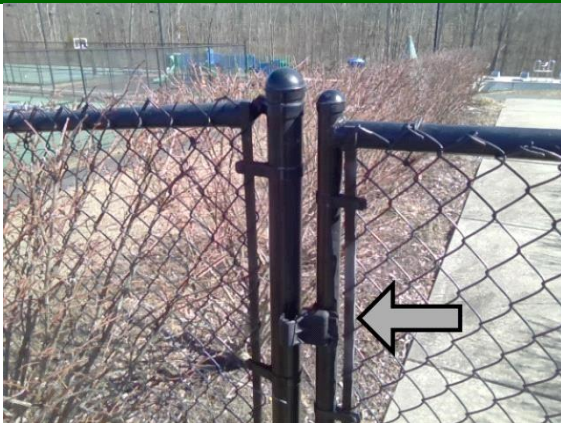
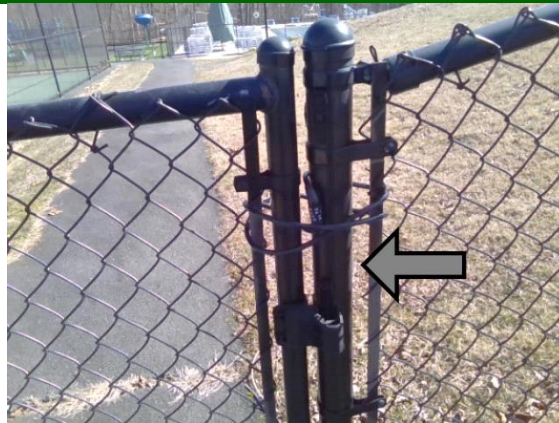
The gate latch on the upper and lower left hand pool gates are damaged.

Fences / Enclosures: damaged gate latch

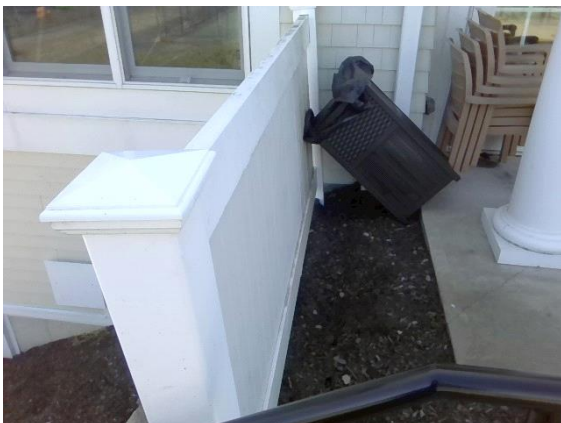
The retaining wall alongside the rear staircase has washed out behind and is therefore causing the security fence to lean.

Retaining Walls: washout & leaning

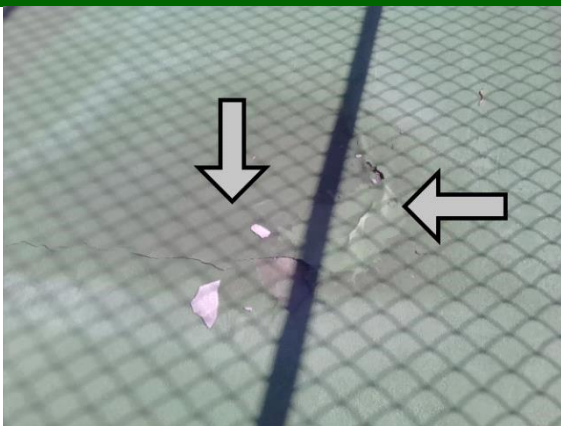
The synthetic surface on the basket ball court is beginning to deteriorated/peel in several locations.

Basket Ball Court: deteriorated court surface

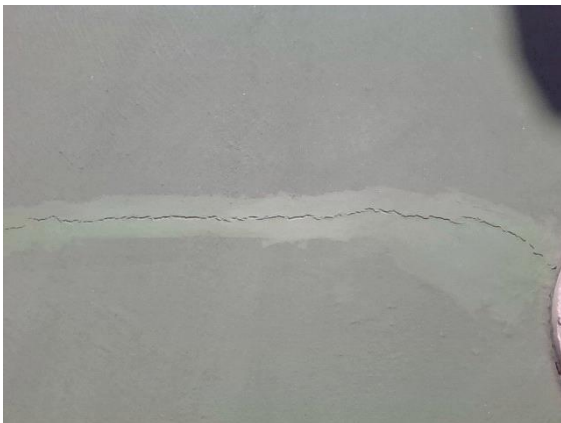
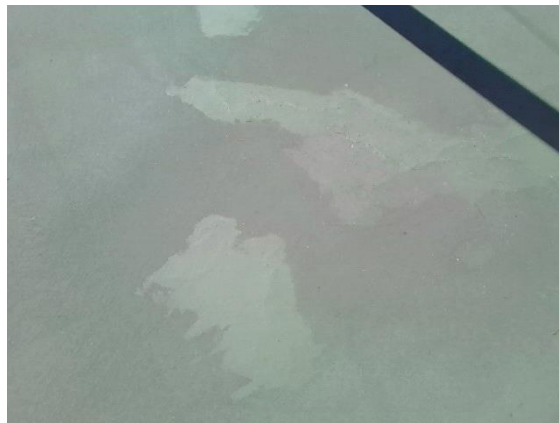
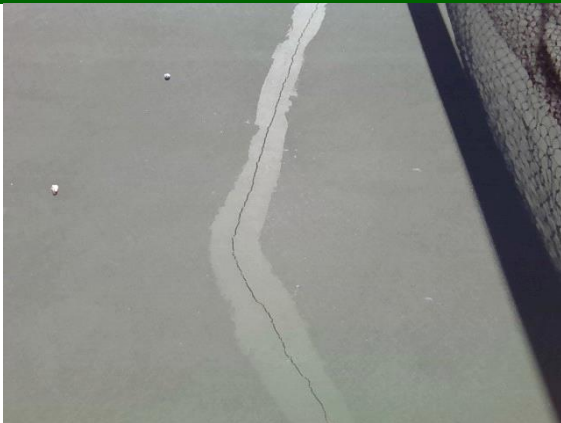
Surface of courts are showing evidence of age appropriate deterioration. Tennis court surface has been repaired previously.

Tennis Courts: cracks & repairs

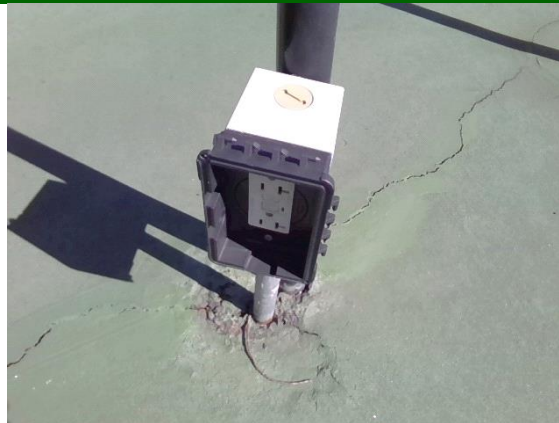
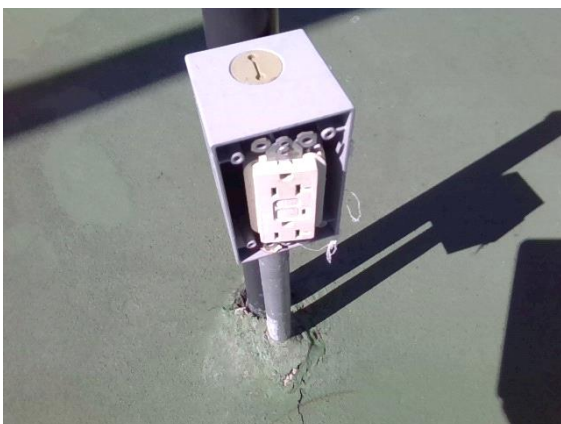
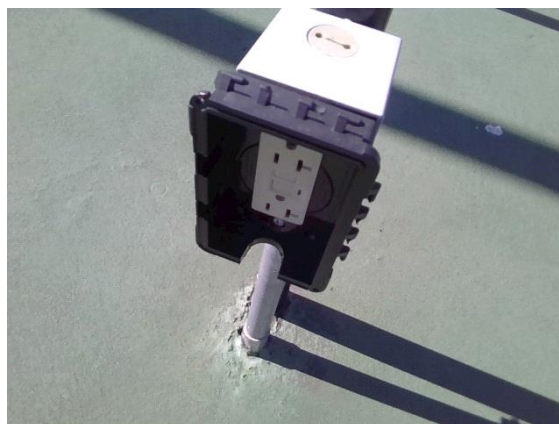
The GFCI outlets supplying utility power to the courts have all been damaged.

Tennis Courts: damaged GFCI outlet

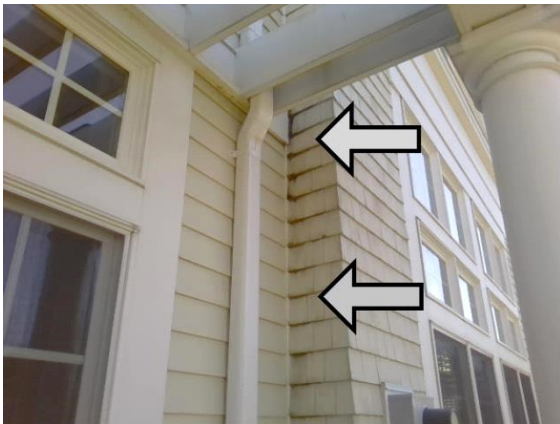
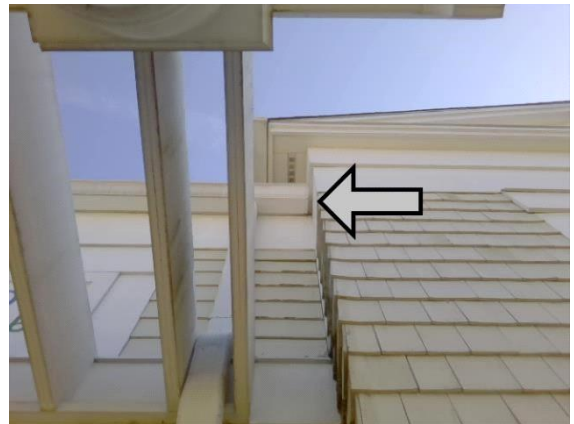
The right hand end of the gutter on the left side of the building is leaking.

Roof Drainage System: leaking gutter

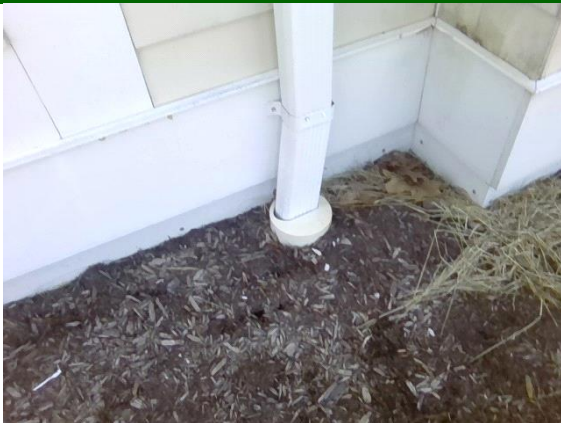
Gutter downspouts around building extend into below grade pipe which presumably carries water to another location for drainage or to other drainage system. Recommend confirming termination and functionality of these downspouts during period of heavy rain.

Roof Drainage System: connection below grade

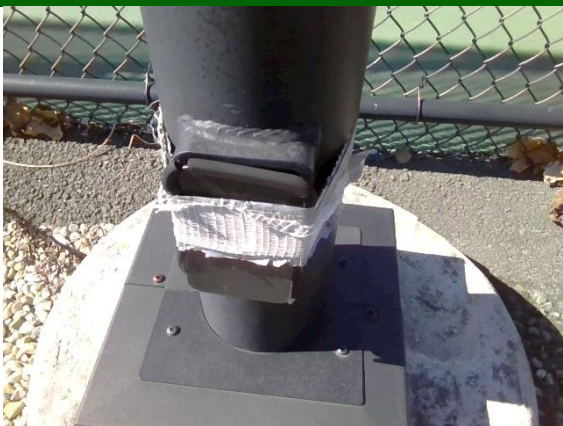
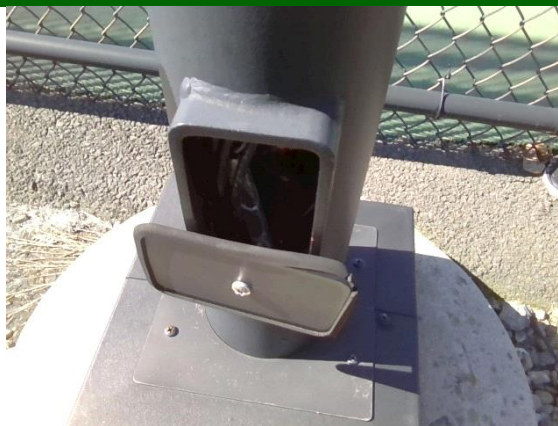
Functionality of exterior lighting systems is outside the scope of this inspection.
Several of the light standards are showing evidence of damage and/or repairs.

Exterior Surface: damaged standard

Several of the light standards are showing evidence of damage and/or repairs.

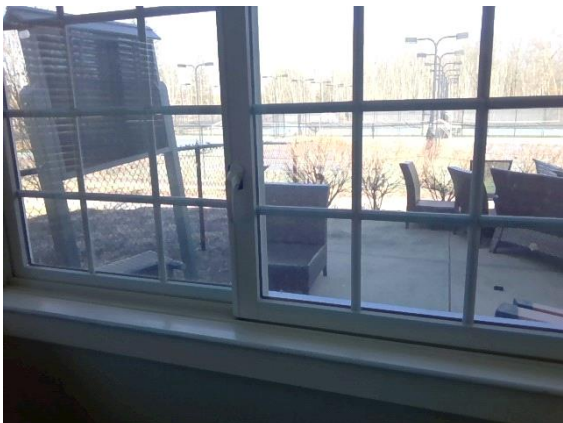
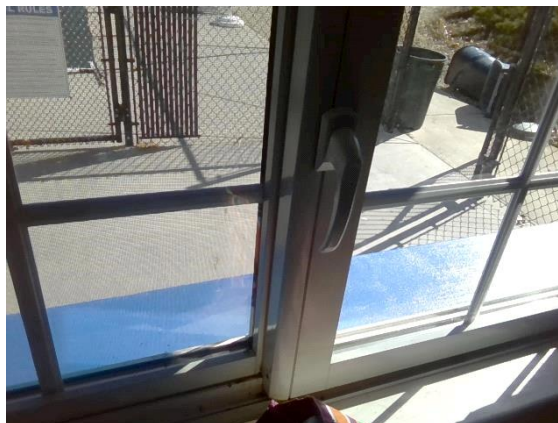
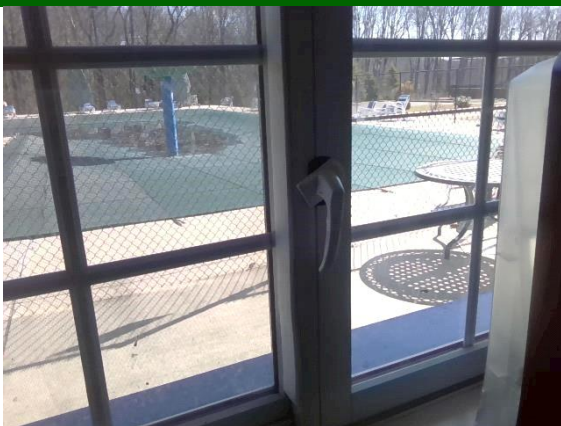
The sliding tracked window to the left in the activity room, to the right in the office/utility room and to the right in the kitchen all have damaged hardware and therefore do not function correctly.

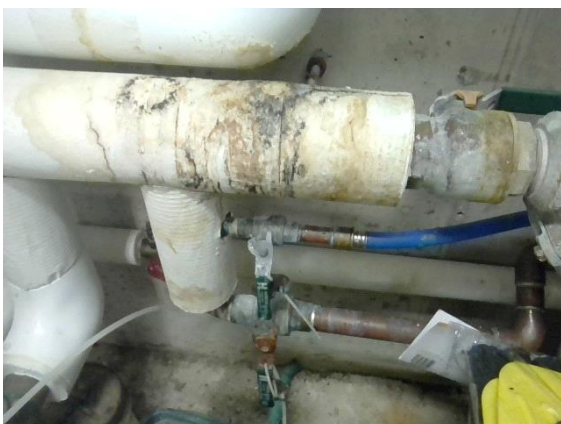
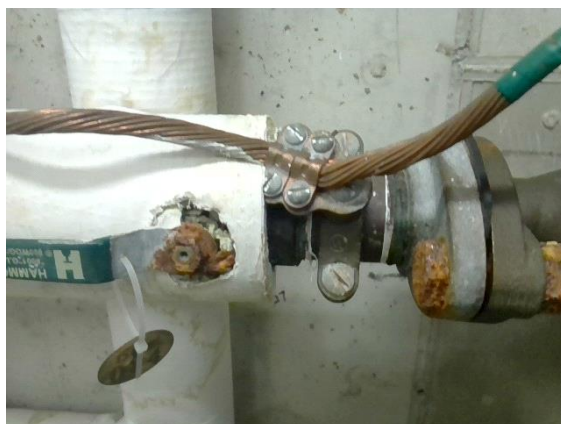
Some corrosion and evidence of minor leaking noted at the water supply.

Plumbing: evidence of leaking

Plumbing: evidence of corrosion

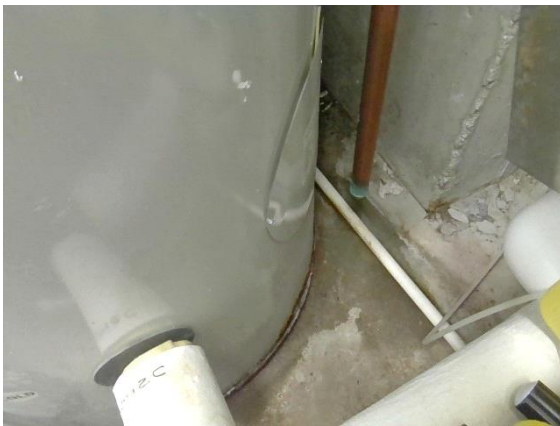
Water heater is at its intended design life. There is evidence of corrosion at the base of the unit. There is evidence of blow off from the Temperature/Pressure Relief valve.

Water Heater: evidence of leaking and blow off

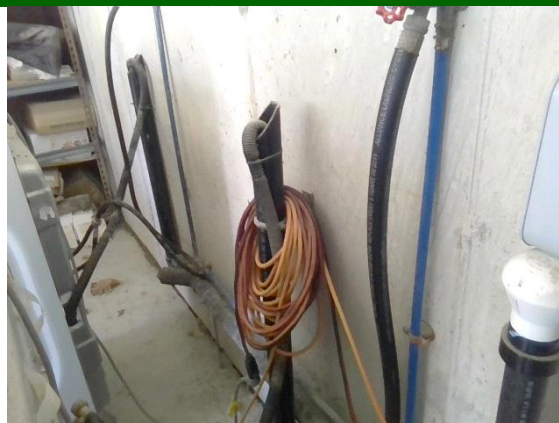
Rubber supply lines to washing machines are showing evidence of deterioration.

Laundry Facilities: rubber hoses

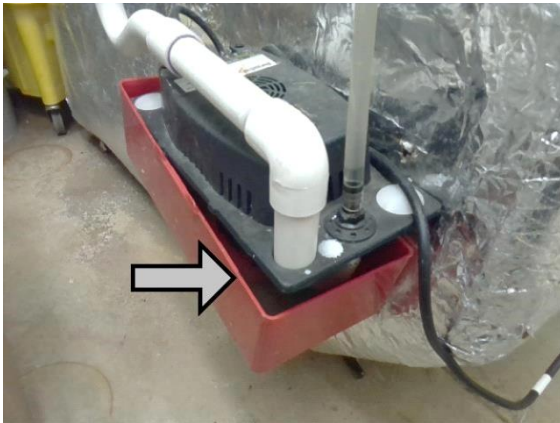
Condensate pump on unit is damaged.

HVAC 3: damaged pump

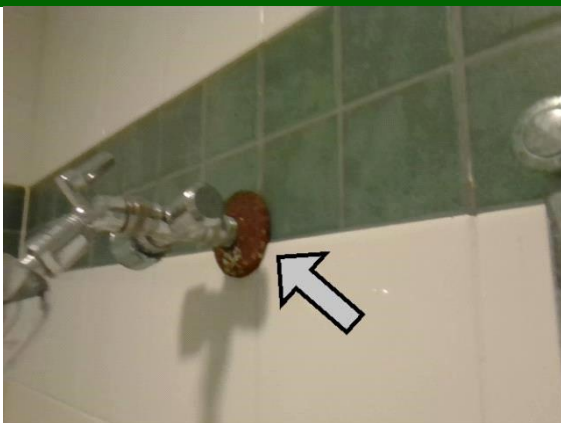
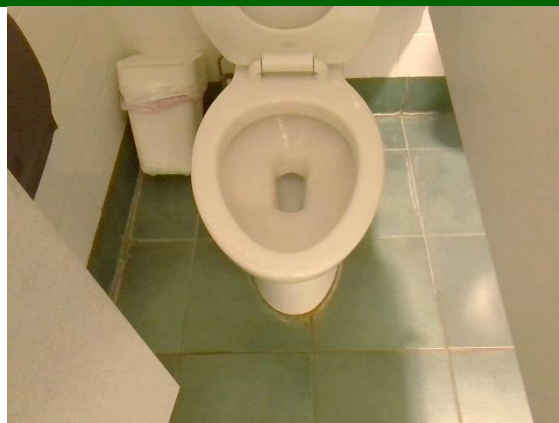
Several shower fixtures are showing evidence of corrosion. Far left stall toilet is loose at the base.

Womens Locker Room: example: corroded fixture

Womens Locker Room: loose toilet base

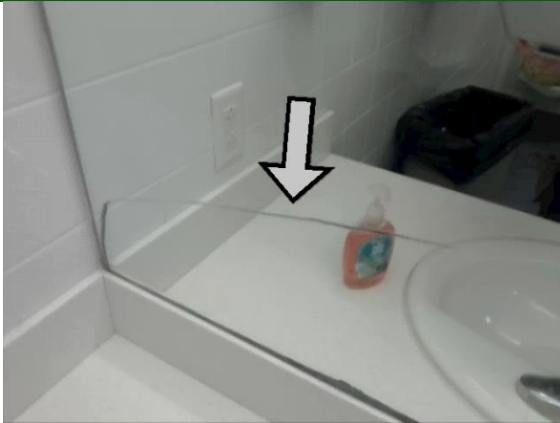
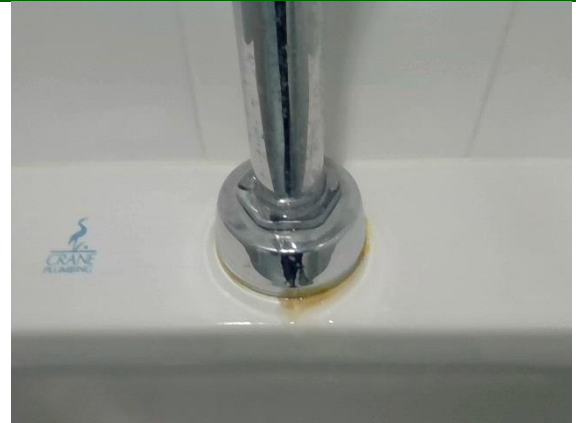
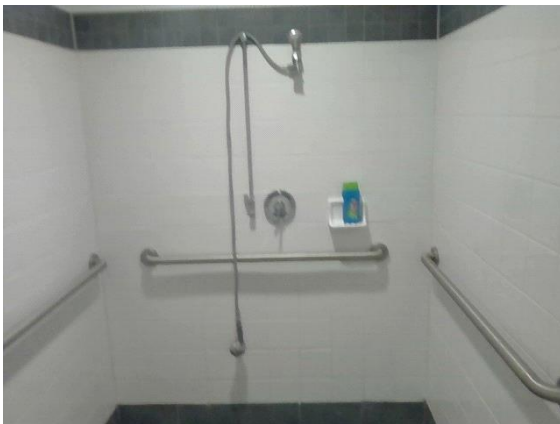
Vanity mirror above sinks is cracked. Right hand urinal flush valve is leaking. Handicapped shower shower head is damaged.

Mens Locker Room: cracked mirror

Mens Locker Room: leaking flush valve

Mens Locker Room: damaged shower head

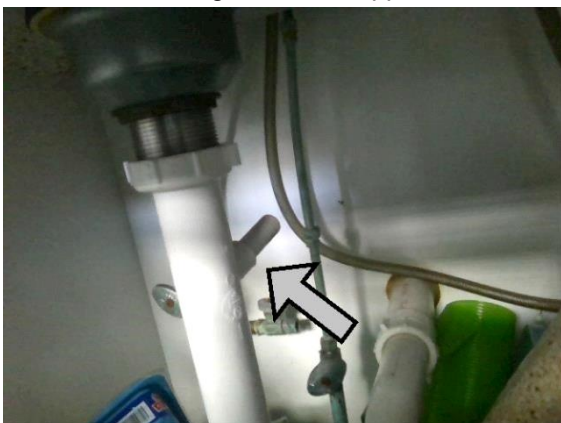
Sink drain is leaking due to uncapped dishwasher drain connection.

Office/Kitchenette: leak in drain

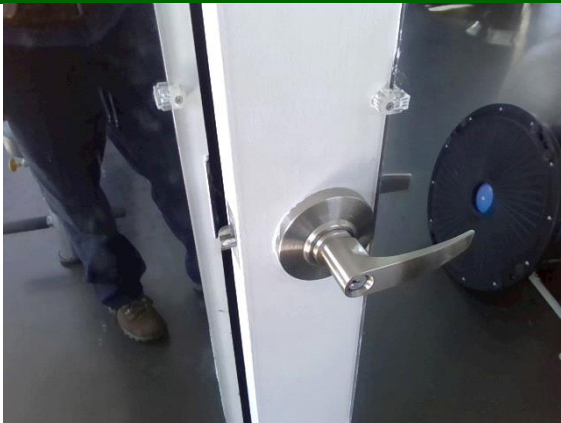
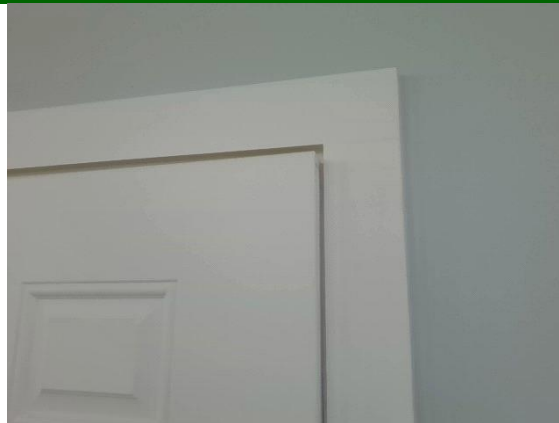
Weights closet door does not latch. Utility closet door is damaged and does not close.

exercise room/playroom: weights closet

exercise room/playroom: utility closet

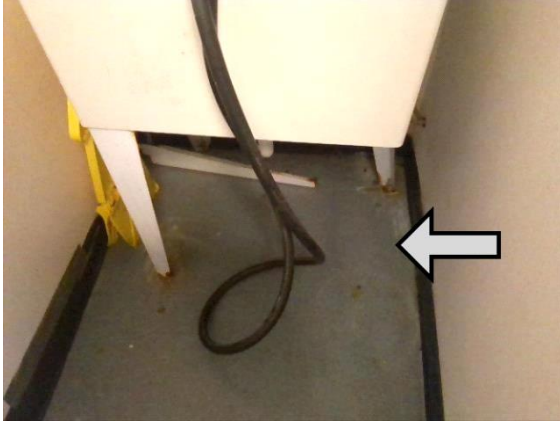
Right leg of utility sink is broken off.

office/utility/Storage: damaged sink
